# **COTTONWOOD DAM**

## **MANUAL FOR OPERATION AND MAINTENANCE**

**Originally Published June, 1995  
Revised July 2001**

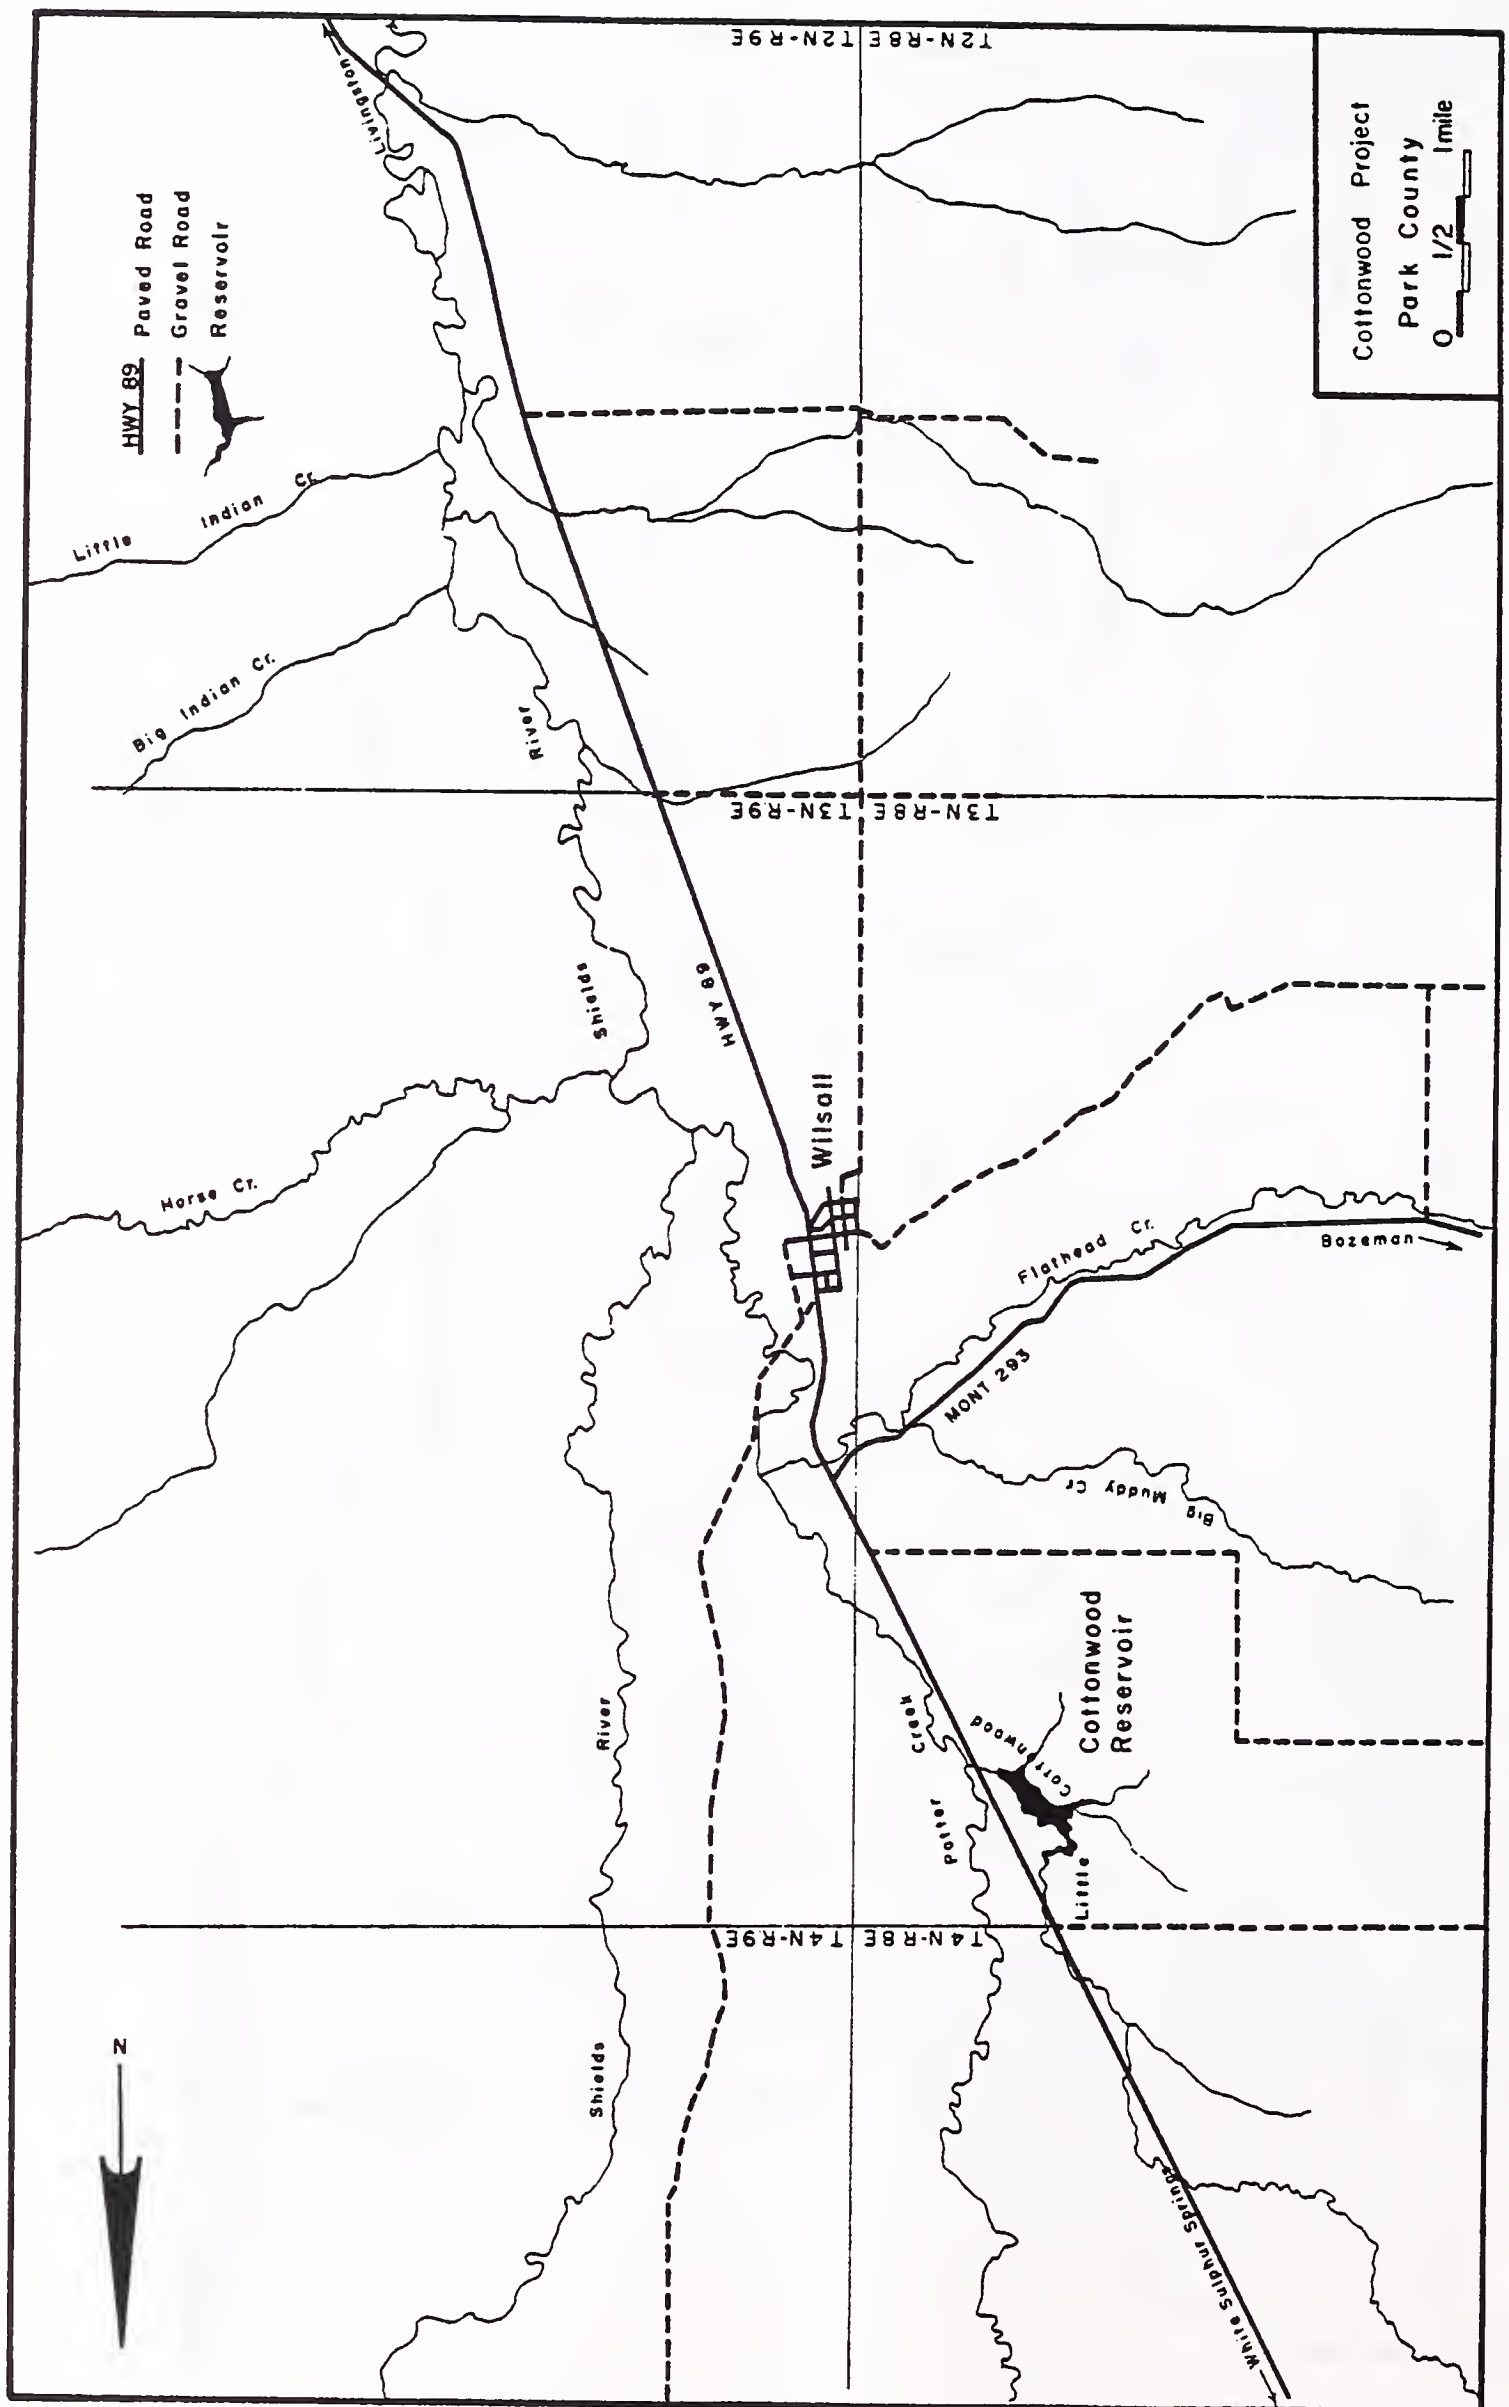
Figure 2. Cottonwood Project Map

Cottonwood Dam is located on Cottonwood Creek, approximately 3 miles northwest of town of Wilsall in Park County. Cottonwood Reservoir impounds runoff from a drainage area of 34 square miles located in Park and Gallatin Counties (See Figures 1 and 2). Figure 3 provides a general layout of the dam, spillway and outlet works. Figure 4 shows the location of the monitoring wells.

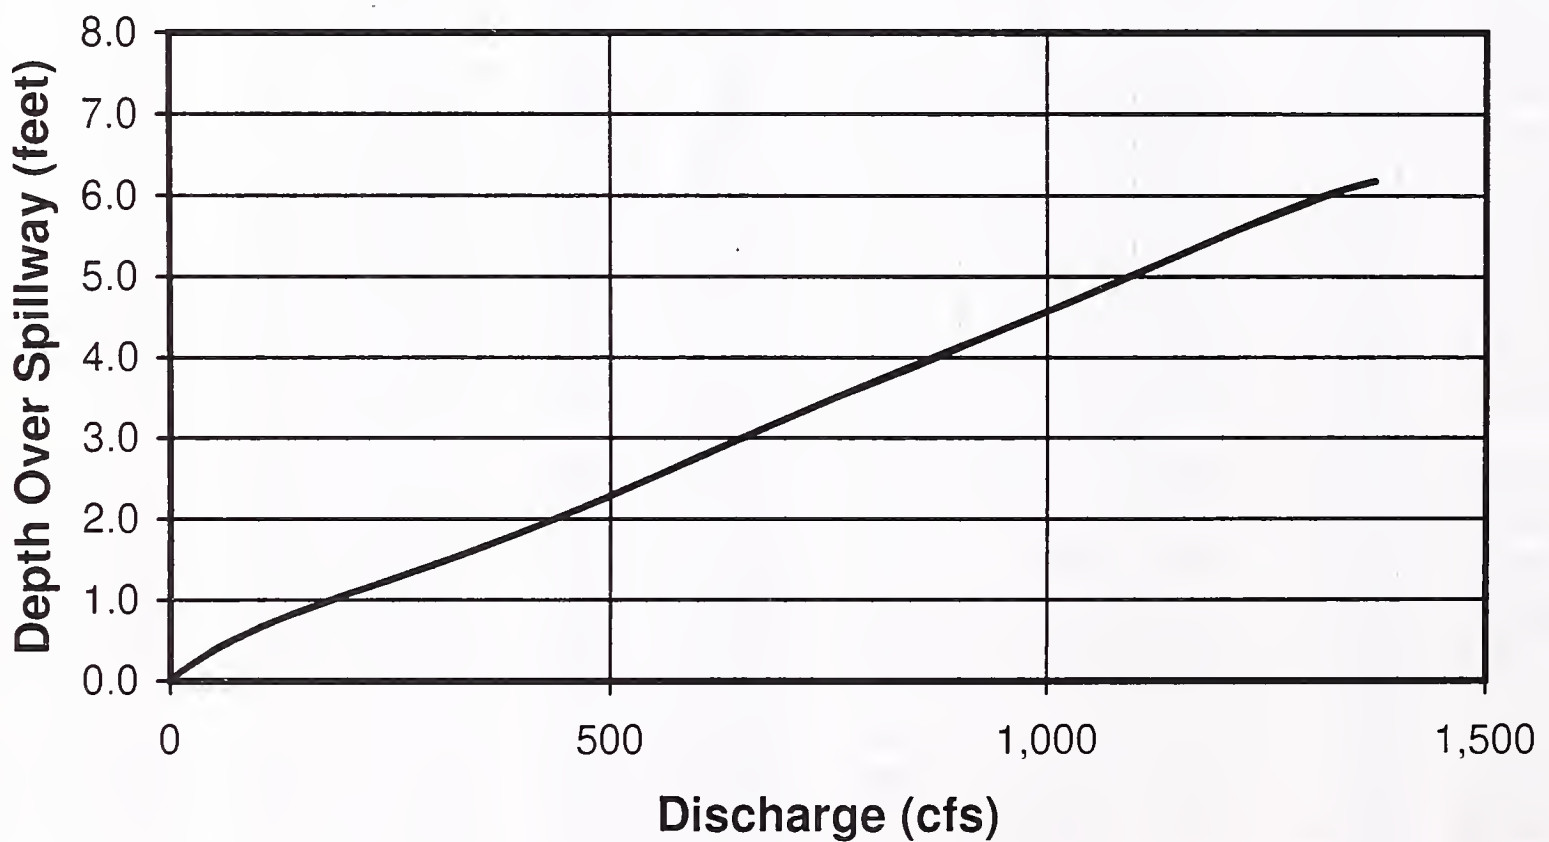
**COTTONWOOD RESERVOIR**

Depth Over Crest (feet)	Elevation (feet)	Discharge (cfs)
0.0	5,102.50	0
0.5	5,103.00	65
1.0	5,103.50	188
2.0	5,104.50	436
3.0	5,105.50	646
4.0	5,106.50	878
5.0	5,107.50	1,088
6.0	5,108.50	1,324
6.2	5,108.70	1,375

Note: Data based on spillway rehabilitation design by HKM (1986).

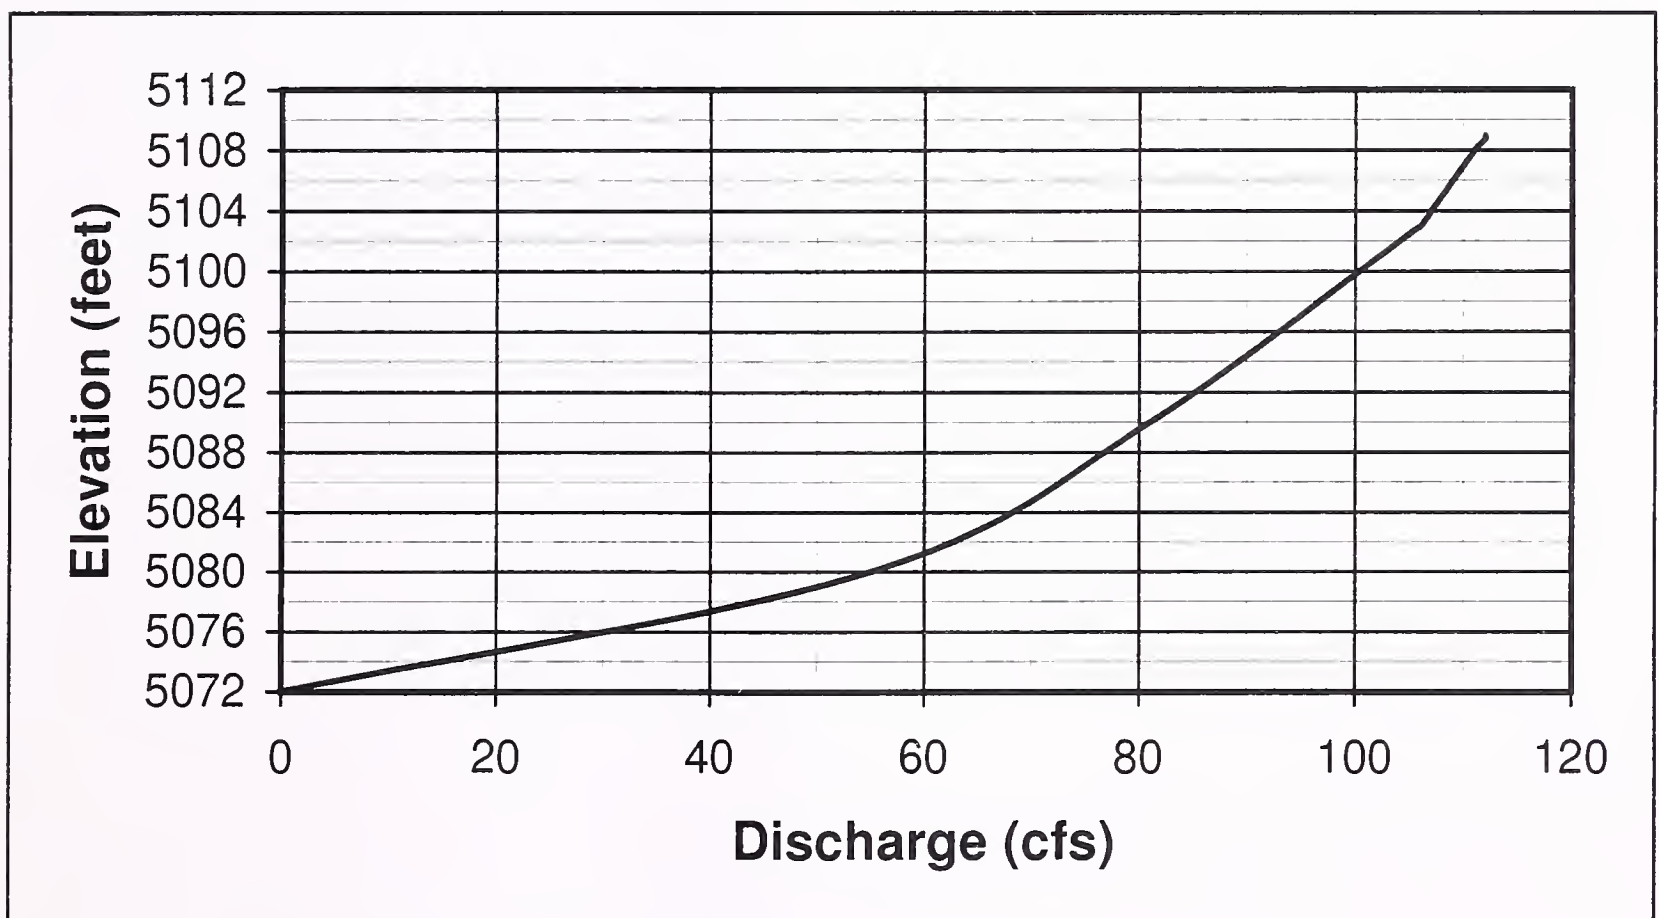
**TABLE 4. OUTLET DISCHARGE**  
**COTTONWOOD RESERVOIR**

Reservoir Elevation (feet)	Discharge (cfs)	Comment
5072	0	
5080	55	
5090	81	
5102.5	105	Guard Dike Crest
5103	106	
5104	107	
5105	108	
5106	109	
5107	110	
5108	111	
5108.74	112	Minimum Dam Crest
5109	112

Note: Discharge assumes operating gate is completely open.

Note: Data from the Corps of Engineers Phase 1 Inspection Report (1981).

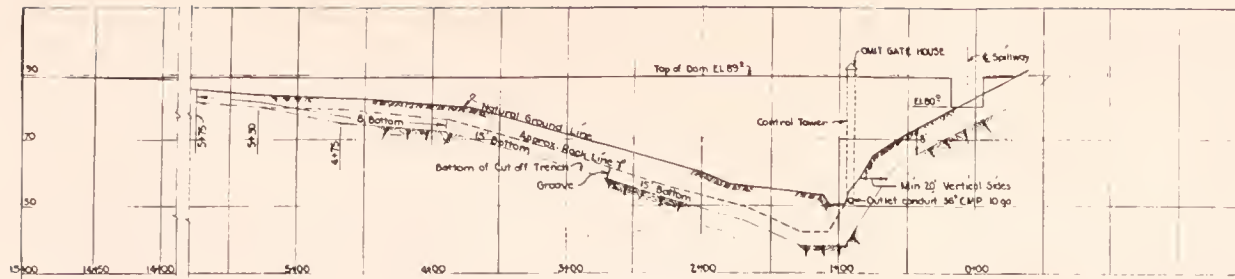
PROFILE

SCALE - 1" = 20' VERT - 1" = 30' HORIZ

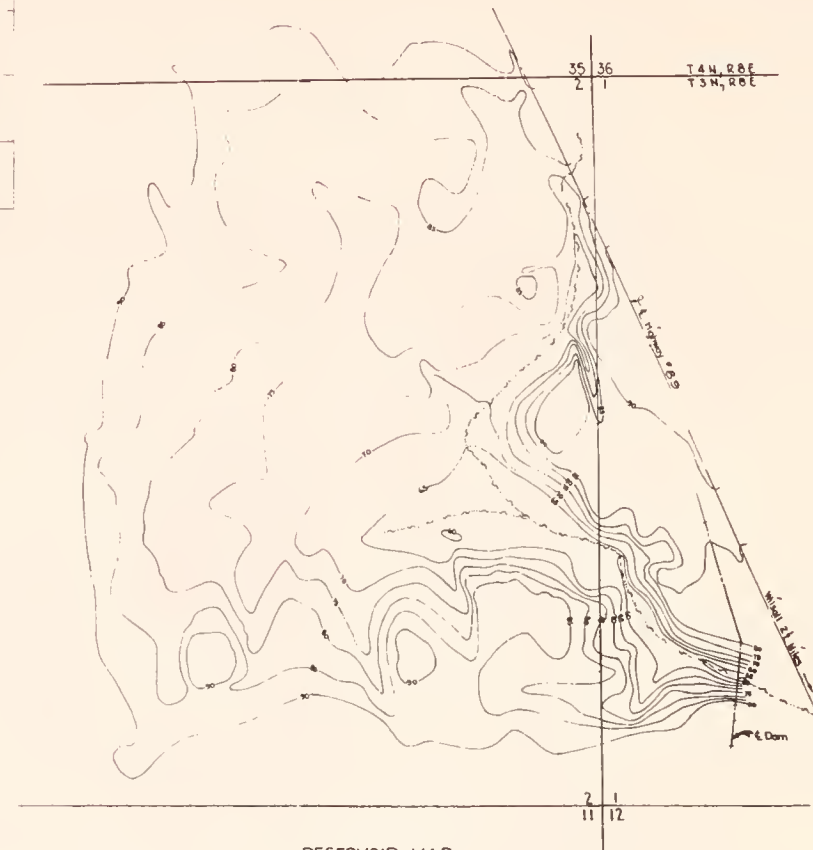
RESERVOIR MAP

SCALE - 1" = 500'

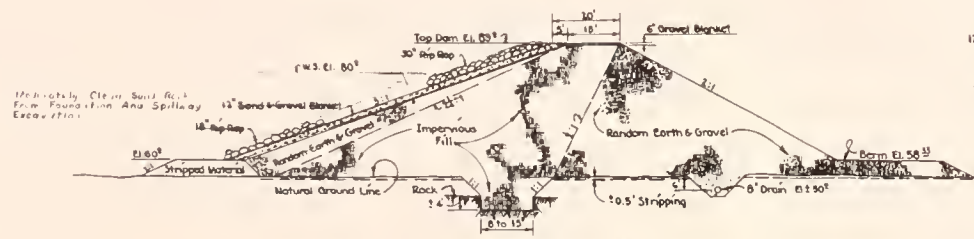
TYPICAL SECTION

SCALE - 1" = 10'
